# **Borehole, surface geologic, and geotechnical data for the Aspen Grove landslide, Sanpete County, Utah**

*Rex L. Baum and Robert W. Fleming*

U.S. Geological Survey Open-File Report 01-413

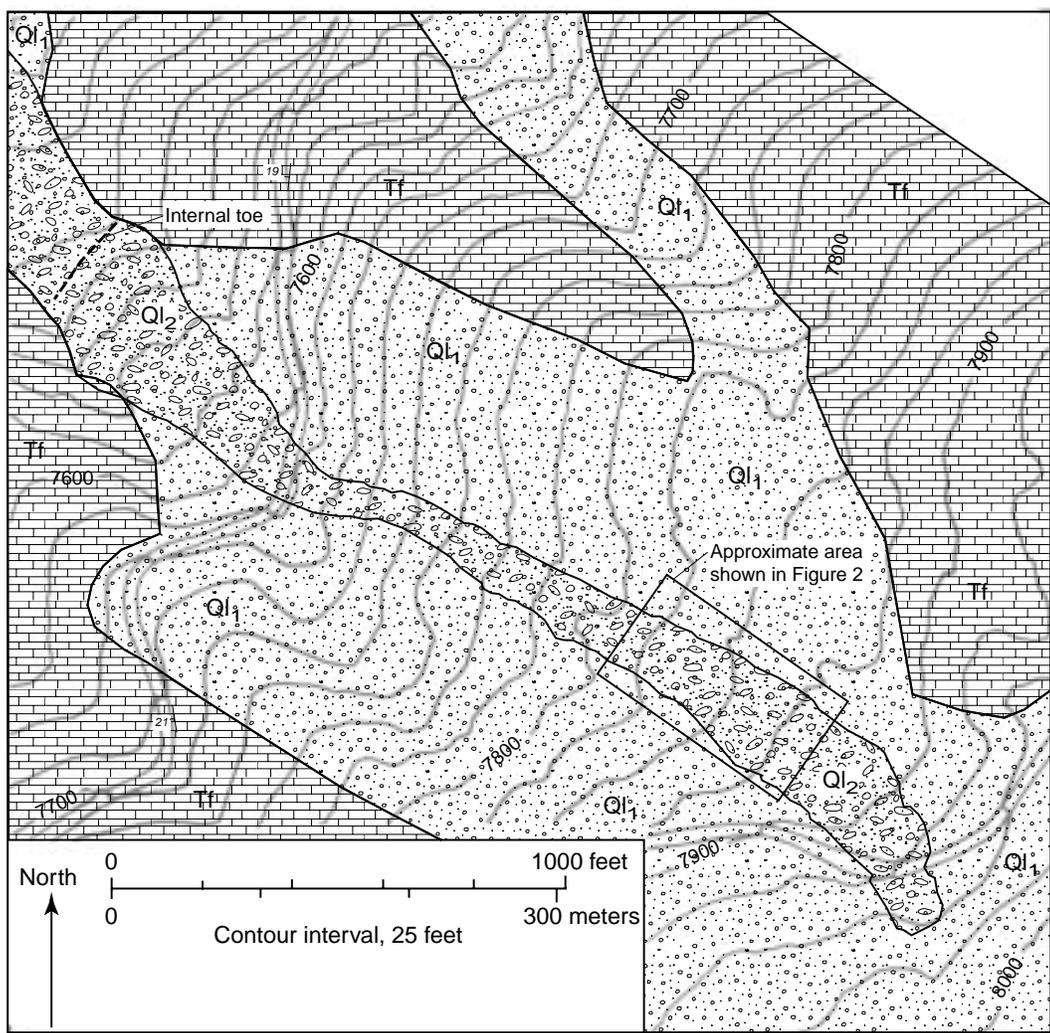
*Figure 1. Simplified geologic map of the Aspen Grove landslide and vicinity. Topographic base compiled by Diana Fair, USGS geologic plotter lab, from aerial photography of 14 June 1983.*

The head of the Aspen Grove landslide is at about 2,423 m (about 7,950 ft) altitude in an assemblage of spruce, fir, aspen, and maple (fig. 1). The toe is at about 2,240 m (about 7,350 ft) altitude in an assemblage of scrub oak and sagebrush. Grasses and shrubs cover the ground surface, and boulders of sandstone jut out of the ground.

The distribution of residuum and landslide deposits closely correlates with topographic position at the site (fig. 1). A thin, discontinuous mantle of residuum covers large, north-trending ridges and some minor troughs. Bedrock crops out at few locations, mainly on ridge crests and in road cuts. Landslide debris occupies the main trough through the center, the branch trough in the northeast, and the low-lying, marshy ground in the northwest corner of the area, beyond the limits of the area shown in figure 1.

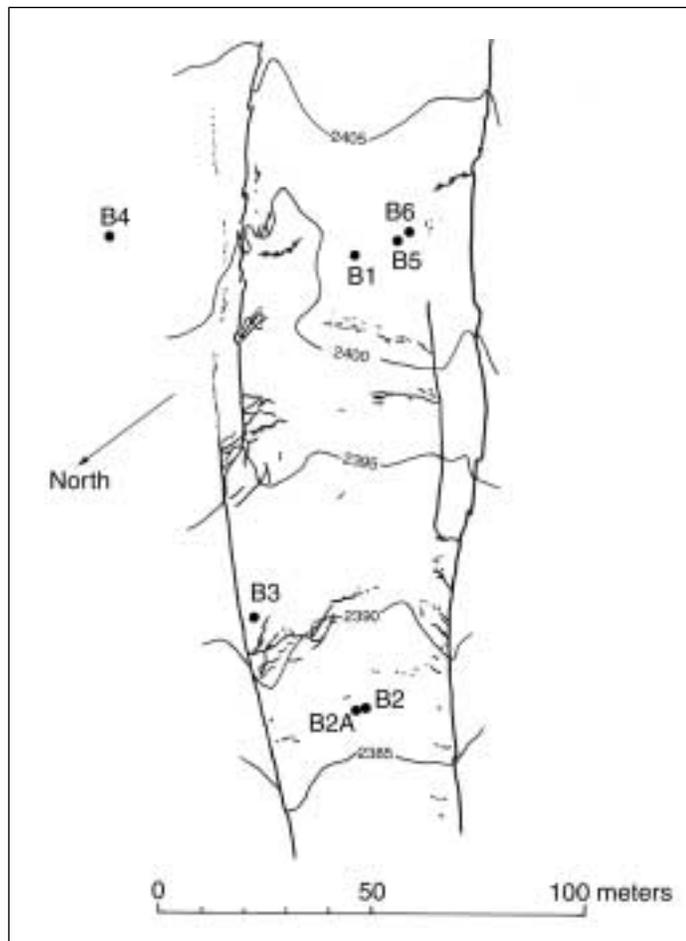
**Figure 2.** Map showing locations of boreholes in the Aspen Grove landslide. Landslide features and topographic contours based on detailed mapping by Fleming and Johnson (1989).

Figure 2 shows the locations of borings drilled by the USGS during the summers of 1984 and 1985. During August 1984, five holes were drilled in the upper part of the landslide with a truck-mounted drill rig formerly operated by the USGS Geotechnical Laboratory, Golden,

Colorado (Roger Nichols, Supervisor). One was drilled in ground adjacent to the landslide (borehole B4, figure 2). Another was drilled through the right flank of the landslide (B3), and three others were drilled near midwidth (B1, B2 and B2A). During July 1985, two new holes (B5 and B6) were drilled near B1. Three undisturbed samples were collected near the bottom of borehole B6 for laboratory testing. Logs of the borings (Appendix A) indicate the methods of drilling and sampling used in each hole, the sample intervals, stratigraphic interpretations, instrumentation and methods of backfilling the boreholes.

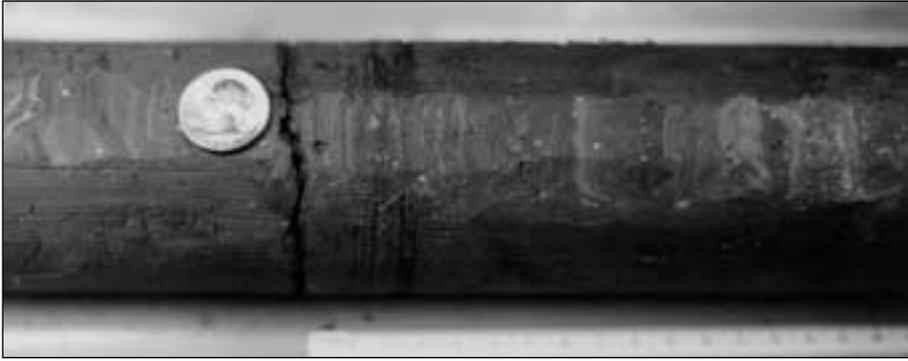
**Figure 4. Photograph of tube sample from borehole B-6. Laminated clay from vicinity of the basal shear zone.**

Tube samples collected in borehole B6, in the upper part of the Aspen Grove landslide, were extruded and examined in the laboratory. Drillers pushed a tube sampler inside a hollow-stem auger to obtain nominally continuous, relatively undisturbed samples between depths of 4.57 m and 6.59 m. Sample recovery totaled 1.51 m, or 75 percent of the total interval sampled. Consequently the depth where samples originated are known only approximately. Several intervals of the tube samples (fig. 3) were thinly laminated, plastic clay, like that shown in figure 4. Alternating intervals were massive plastic clay or silty clay.

Study of the tube sample suggests that the failure zone or slip surface of the landslide passed through the laminated clay at depths of 6.15 or 6.52 m (fig. 3). A crack and some poorly developed slickensides that dipped about 15° were observed at a contact between silty clay and laminated clay at a depth of 6.15 m. There was a disturbed zone at the base of the tube sample in greenish-gray, waxy shale at a depth of 6.52 m, but much of the disturbance was due to drilling, because the most obvious

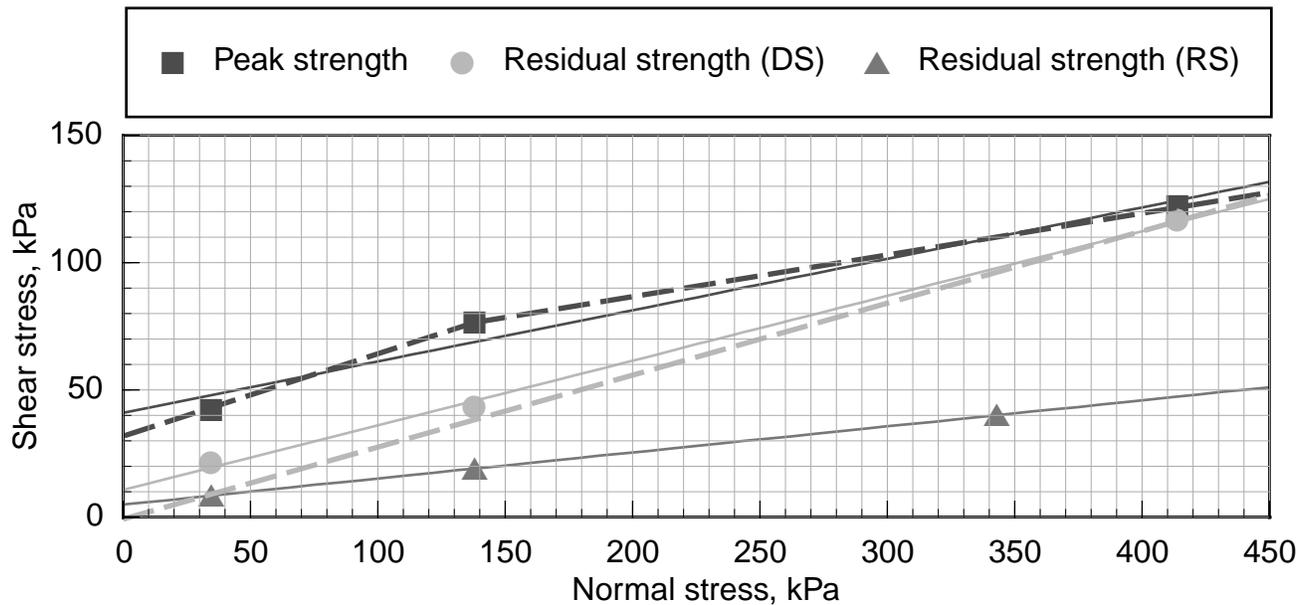
**Figure 5. Failure envelopes for sample AG3-1 from about 6.3 m depth in borehole B-6. Peak shear strength, dashed black line represents segmented strength envelope; solid black line represents best fit straight-line envelope. Residual strength by direct shear (DS), dashed light-gray line represents lower-bound estimate through the origin and the strength at the highest normal load; solid light-gray line represents best fit straight line envelope and upper bound estimate of the residual strength. Residual strength by torsional shear (RS) solid gray line represents best fit straight-line envelope.**

Test results for a sample from the basal shear zone of the landslide are of particular interest. The strengths of the specimens are plotted as a function of normal stress in figure 5. The peak strength defines a segmented failure envelope. The intercept is about 31 kN/m<sup>2</sup> and the segment defining peak strengths at lower normal stress slopes about 18°. The segment defining peak strengths at higher normal stresses slopes about 9°.

Upper- and lower-bound estimates of the residual strength are also shown in figure 5. The upper-bound estimate uses the strength at the end of each direct-shear test. The upper-bound failure envelope has an intercept of 10.8 kN/m<sup>2</sup> and slopes 14.3°. The lower-bound estimate uses the residual strength determined for the specimen tested under a normal stress of 414 kN/m<sup>2</sup>, and projects through the origin. Slopes of the stress-displacement diagrams (Appendix B) indicate that the specimen tested under a normal stress of 414 kN/m<sup>2</sup> was the only one of the three that attained its residual strength after 9 mm of shearing. The lower-bound estimate has an intercept of 0 kN/m<sup>2</sup> and slopes 15.8°. A torsional shear test on material from the same interval had residual-strength parameters of 5° and 5.2 kN/m<sup>2</sup>. Removal of particles larger than 0.425 mm from the torsional shear test specimens may have reduced the strength slightly relative to the total sample; however, the coarse particles accounted for only about 2 percent of the total.

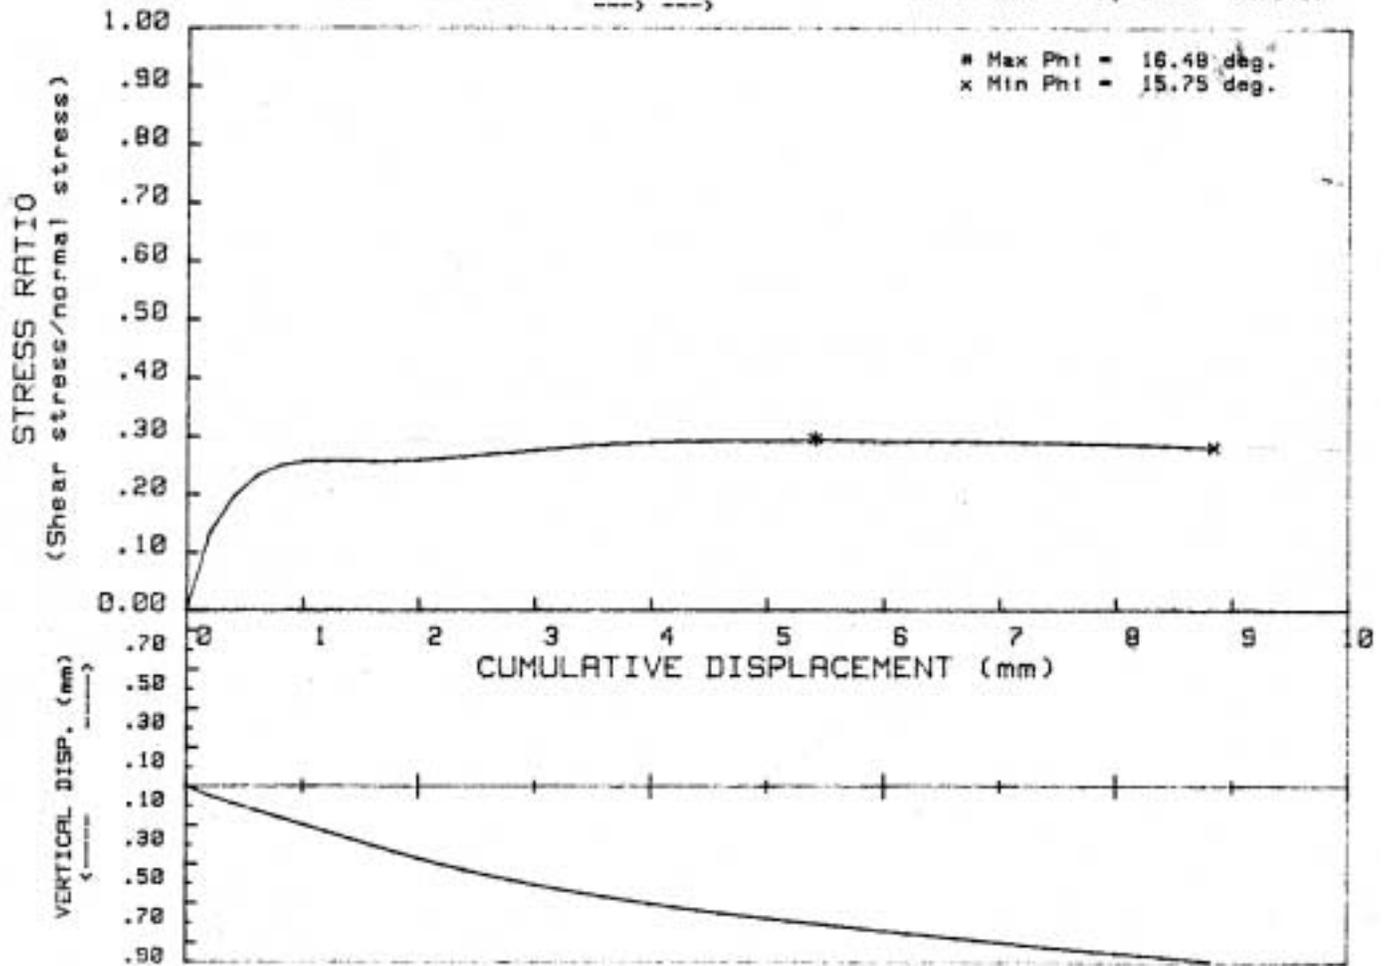
RG3-1  
B21  
BAUM  
Date -- 11/8/85

Normal load (kN) - - -1.3184  
Shear rate. (mm/min) - .0248  
Total disp. (mm) - - - 8.81  
Area (meters squared) .003167

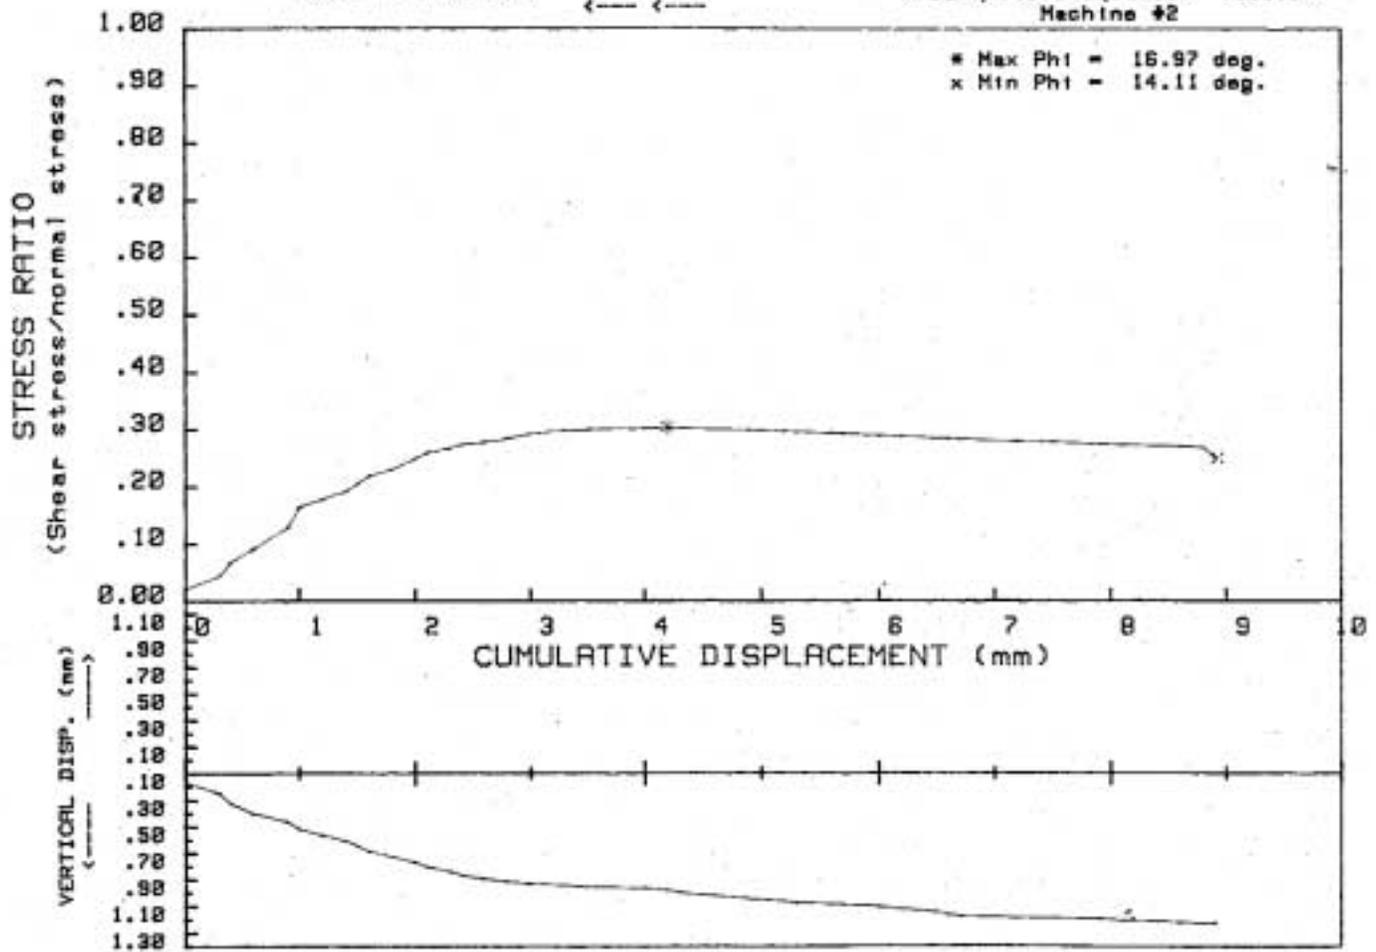
DH4-1  
RF18  
FLEMING  
Date -- 11/28/ 84

Normal load (kN) - - -1.2126  
Shear rate. (mm/min) - .2048  
Total disp. (mm) - - - 8.98  
Area (meters squared) .883167  
Machine #2

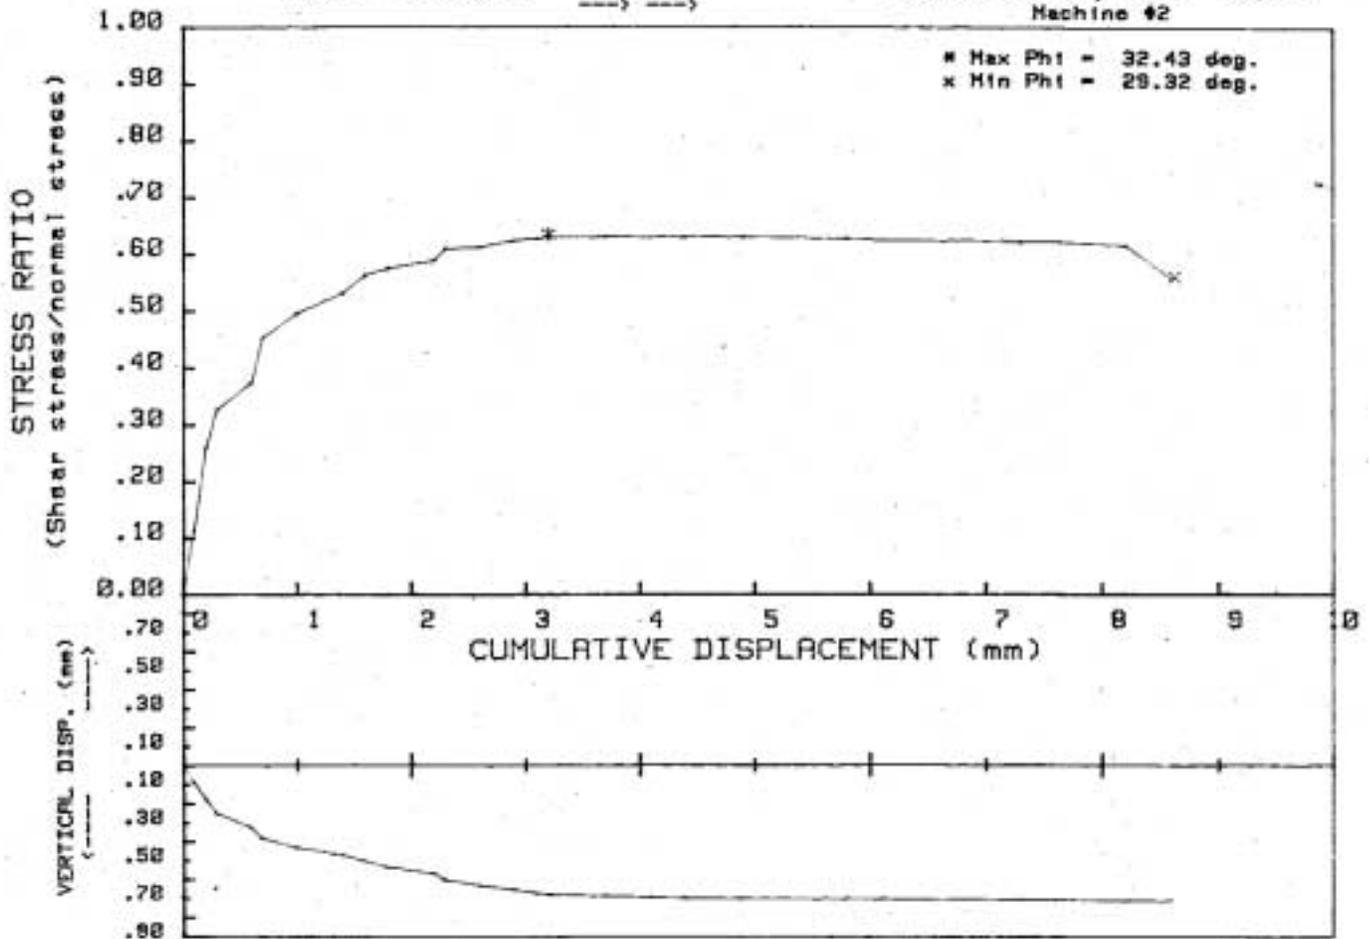
DH4-2  
RFS  
FLEMING  
Date — 11/16/ 84

Normal load (kN) - - - .1516  
Shear rate. (mm/min) - .8848  
Total disp. (mm) - - - 8.68  
Area (meters squared) .083167  
Machine #2

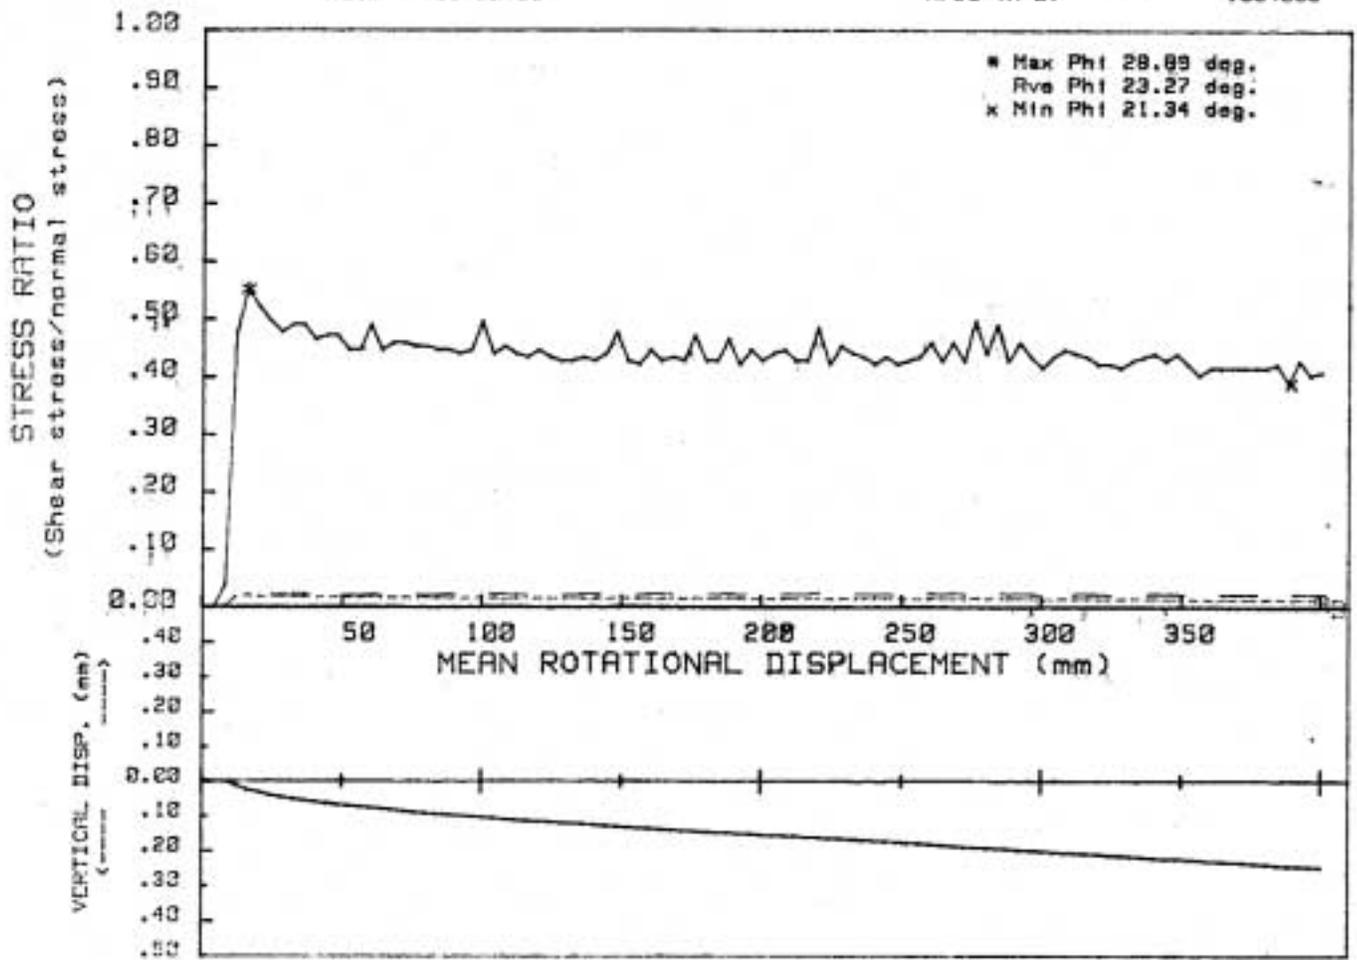
AG1-1  
B1  
BFLUM  
Date -- 11/22/85

Normal load (kN) - - - .1381  
Shear rate, (mm/min) - .267  
Total disp. (mm) - - - 400.87  
Area (M<sup>2</sup>) - - - .834606

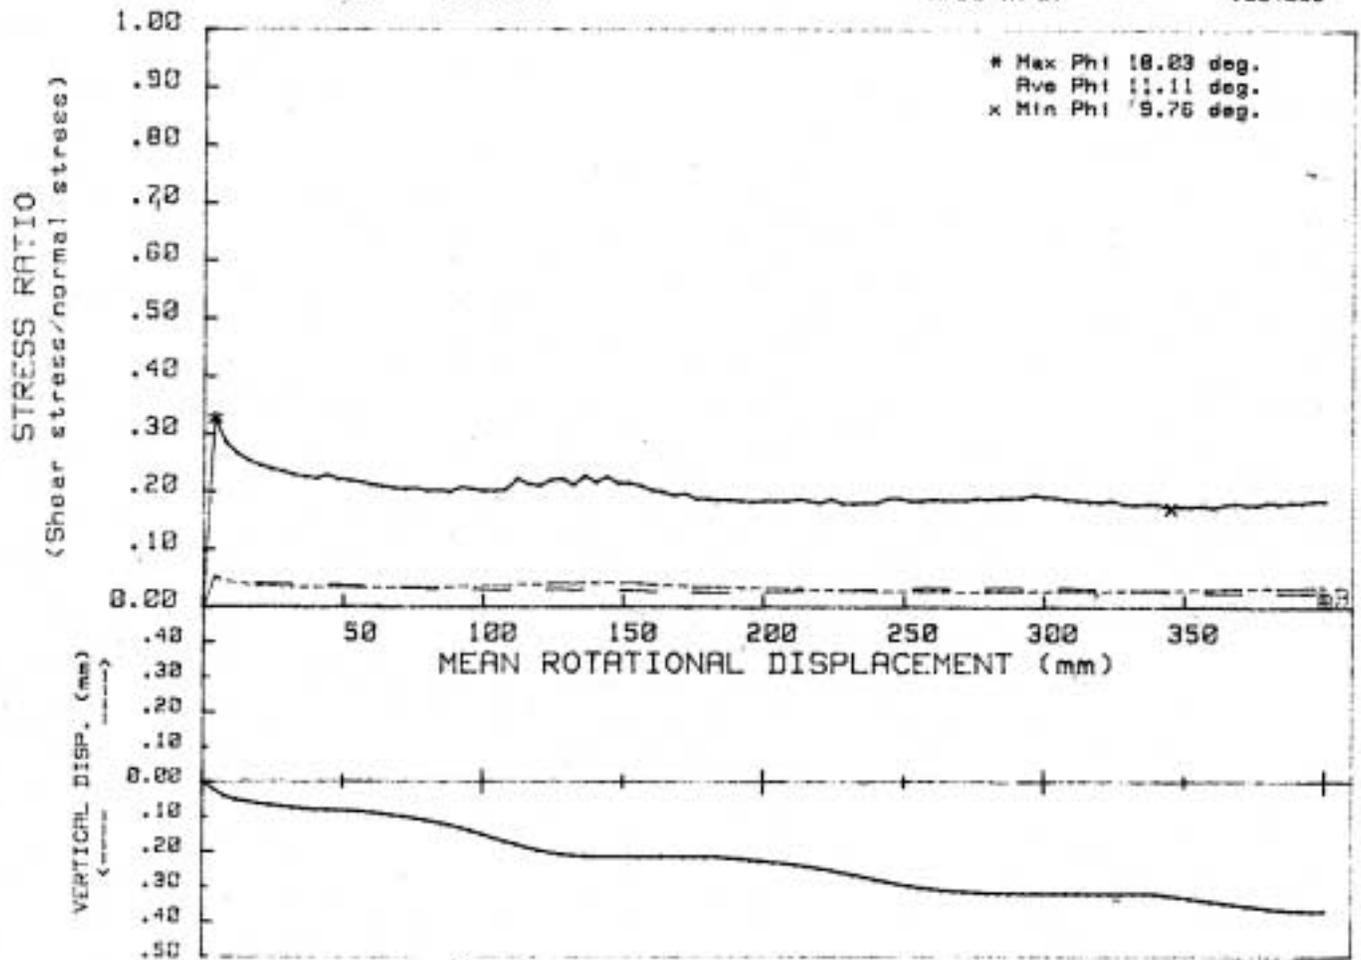
RG1-1  
B2  
BRUN  
Date -- 11/27/85

Normal load (kN) - - - .5525  
Shear rate, (mm/min) - .267  
Total disp. (mm) - - - 400.00  
Area (M<sup>2</sup>) - - - .804000

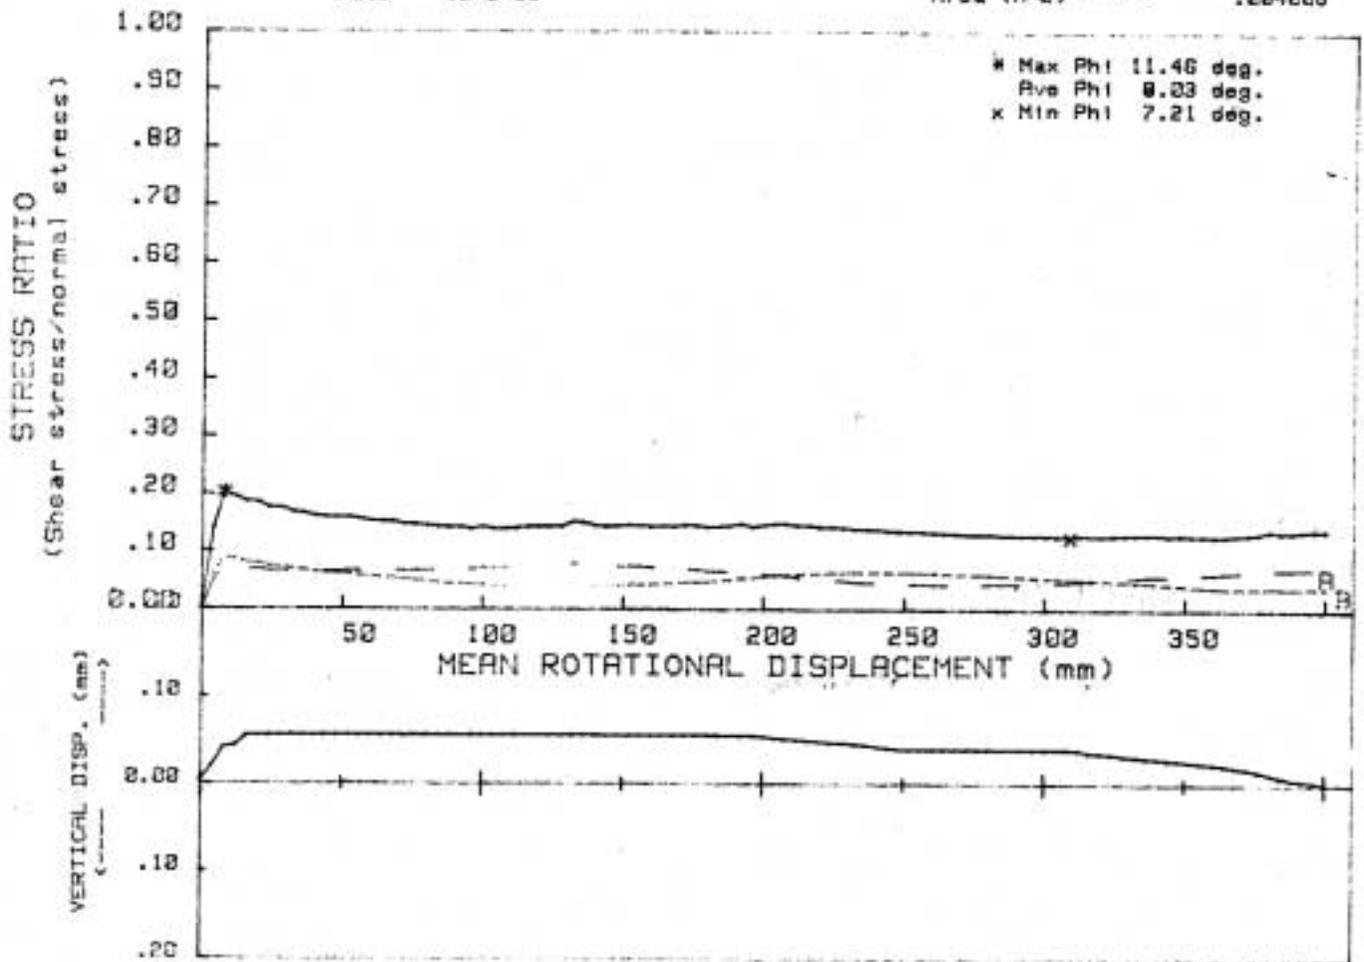
AGI-1  
B3  
BRUM  
Date 12/3/85

Normal load (kN) - - - 1.3813  
Shear rate. (mm/min) - .257  
Total disp. (mm) - - - 400.09  
Area (M<sup>2</sup>) - - - .284886

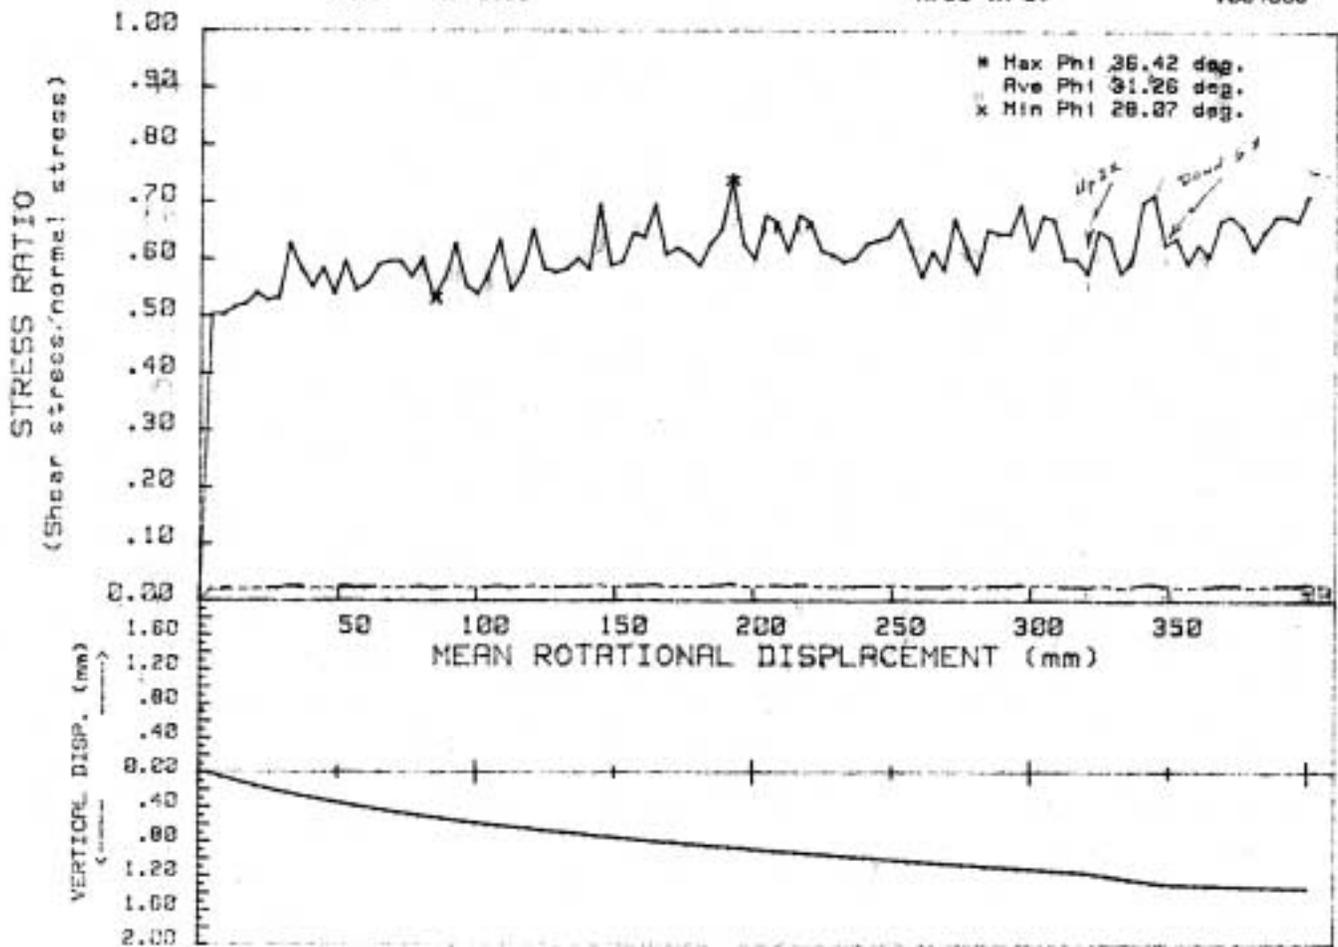
AG1-2  
B4  
BRUH  
Date -- 12/6/85

Normal load (kN) - - - .1381  
Shear rate. (mm/min) - .267  
Total disp. (mm) - - - 402.08  
Area (M<sup>2</sup>) - - - .004086

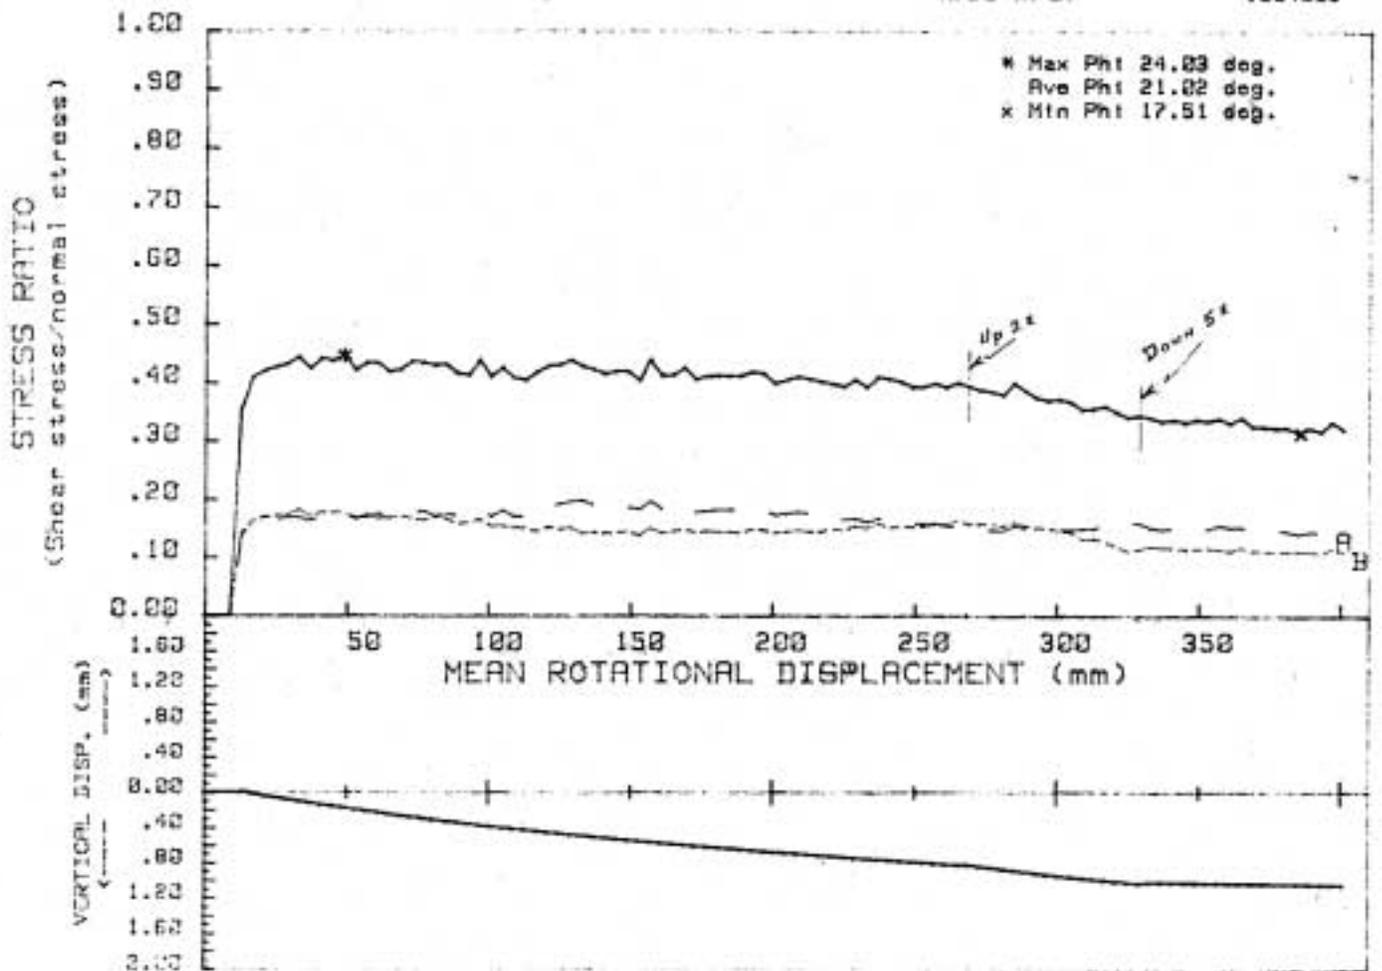
AG1-2  
 BG  
 BALM  
 Date -- 12/18/85

Normal load (kN) - - - 1.3813  
 Shear rate. (mm/min) - .267  
 Total disp. (mm) - - - 400.77  
 Area (M<sup>2</sup>) - - - .004886

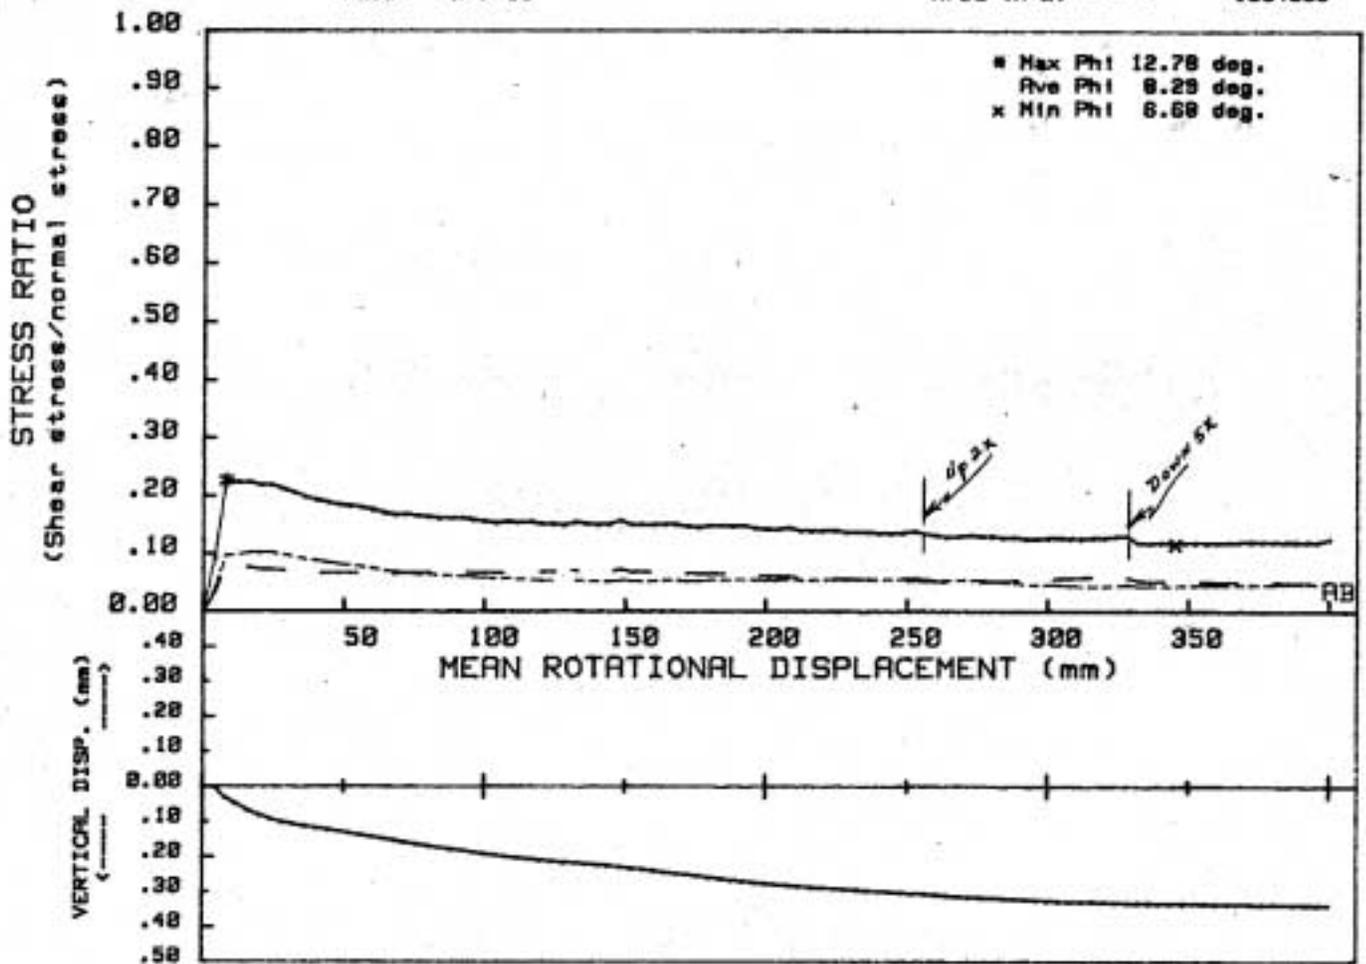
RG3-1  
B17  
BALM  
Date — 2/7/88

Normal load (kN) - - -1.3738  
Shear rate, (mm/min) - .267  
Total disp. (mm) - - - 488.08  
Area (M<sup>2</sup>) - - - .884886
